Inspection Report

Date of Report: July 15, 2008

Mine Name: Milla' Martinique
Operator Name: Martinique Mining

Permit number: S0170046
Inspection Date: May 12, 2008
Time: 1:00-1:20 PM

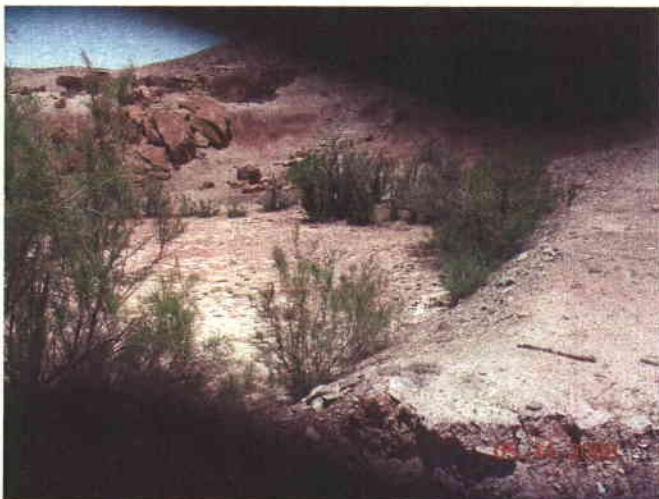
On the north side of the site is a series of small impoundments, and the dams have breached (Photo 1). (Unfortunately my lens cover did not fully open, and I was not aware of this until getting the pictures off the camera.) Vegetation around these ponds is mostly greasewood. On the southeast side is a larger impoundment with a lot of tamarisk around the edges (Photo 2), but as far as I can determine, this pond is not part of the operator's responsibility (see discussion under conclusions and recommendations below).

Photo 1. This is a small pond on the north side of the site where the dam has breached.

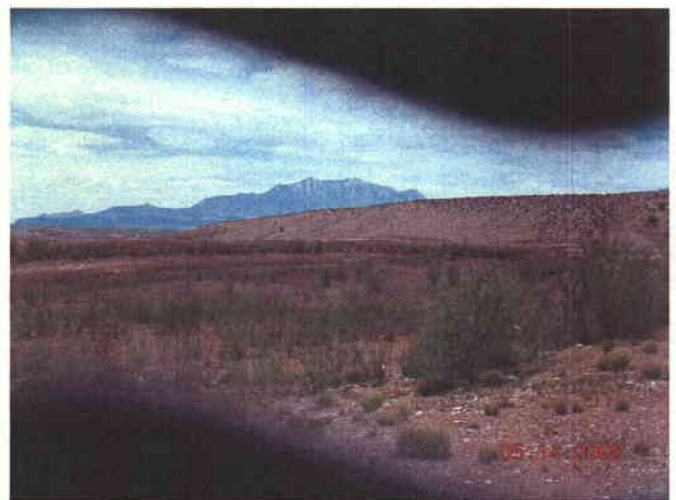
According to the NOI, tailings would be stored in a small pond and cleaned up and stacked for testing. This small pond is not the same as the larger pond, and I was unable to see any sign of the smaller pond. Buzz Rakow of the BLM said the BLM has not considered the pond as part of Milla' Martinique.

Photo 2. This pond is adjacent to the mill site but is not part of the operator's responsibility.

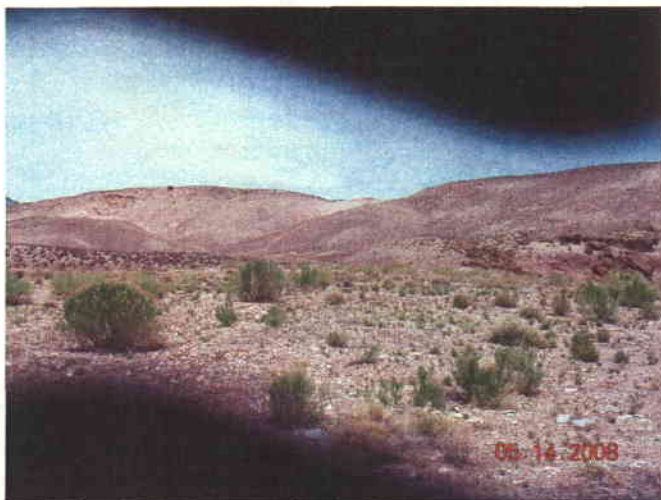
Vegetation in the reclaimed area also varies widely, but in this case it is more because of the degree of compaction of working areas. I estimated cover to be 14.7 percent. Most of the vegetation is rabbitbrush, and there are a lot of rabbitbrush seedlings.

Photo 3. This picture and Photos 4 through 6 show the reclaimed area and some of the adjacent undisturbed areas.
